## **California State Board of Equalization Building Assessment**

450 N Street  
Sacramento, California

### **Final Report**

*Project No. 2372-572*

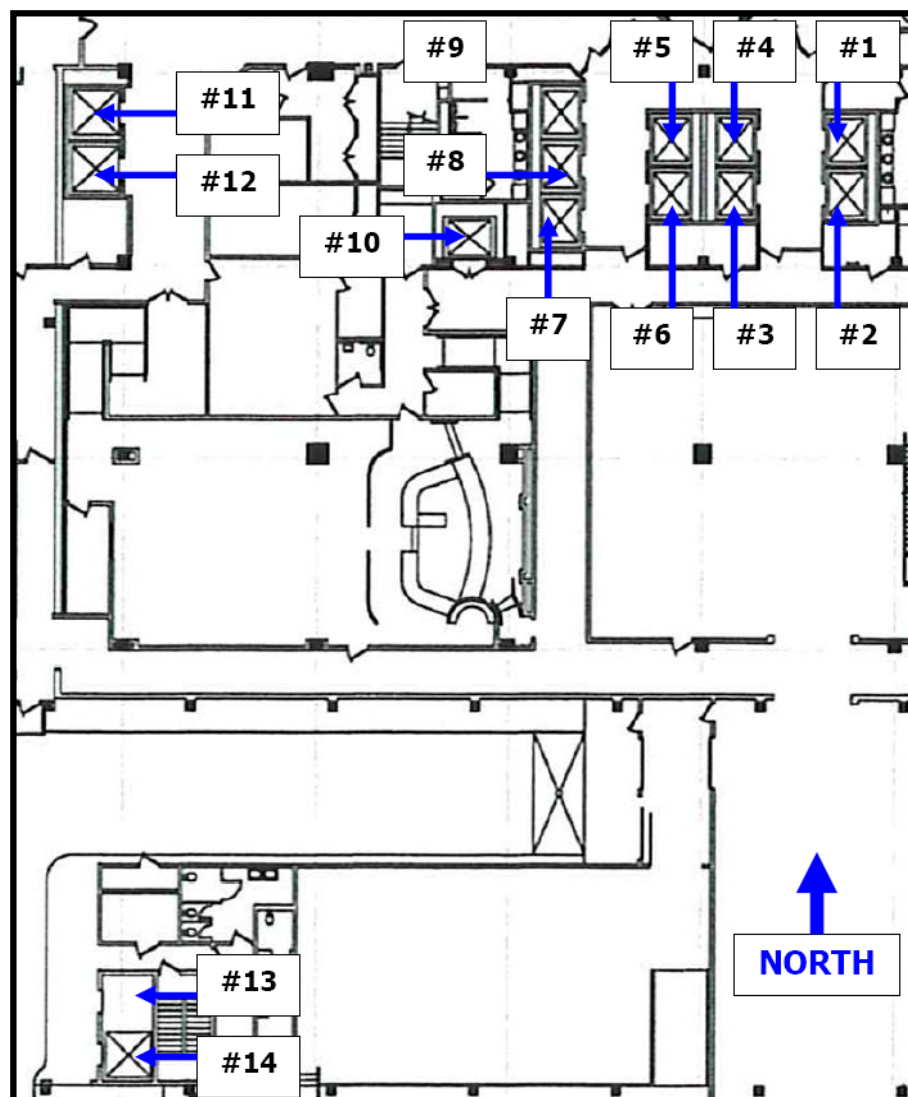
Figure 3.1 Elevator Car Location Plan

Less than one percent of the visually inspected elevator shaft surface area showed signs of what appears to be visible mold growth. Less than ten percent of the visually inspected surface area showed varying degrees of water staining.

The water staining and suspect mold growth in the east low rise elevators (Elevators #1 & 2) appear to be related to water leaks from the janitor rooms and the women's rest rooms adjacent to these elevator shafts. It appears that water staining and suspect mold growth in the other elevator shafts may be due to a variety of causes as identified during the interview and document review phase of the investigation, with no single event or events being able to account for both the historical and current conditions.

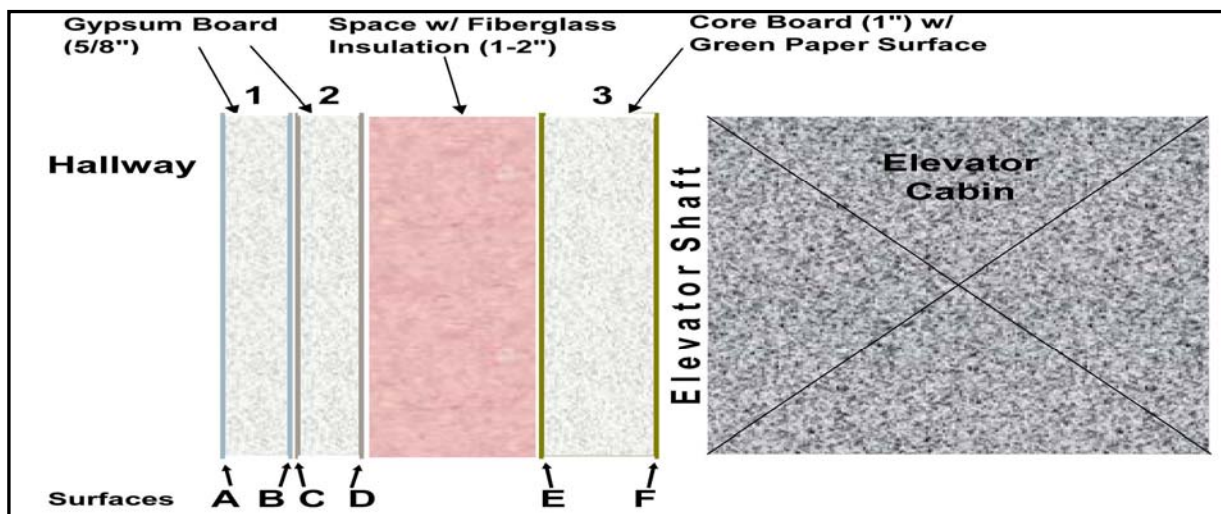
Figure 4.3 Elevator Shaft Wall Detail

Visible mold growth was detected on various wall surfaces with the exception of the elevator shaft core board exterior. All investigation locations of elevator shaft core board exterior (see Figure 4.3E) were observed or tested to be free of mold growth.
